Evaluation of Vehicle Tyre Aging Awareness as a Potential Hazard to Road Users in Ghana

Arnold DUMENYA¹, Maxwell Selase AKPLE (PhD)² and Emmanuel Obobi TETTEHFIO³

¹Assistant Lecturer, Department of Mechanical Engineering, Ho Technical University, Ho, GHANA

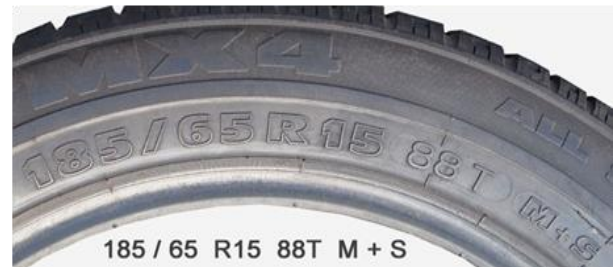
Figure 1: Tyre Image Showing Tyre Markings

Tyre marking is a very important aspect of vehicle tyres. It contains all the essential information about the tyre. In this study, participants were asked some vital questions relating to tyre markings. Participants were instructed to assume **185 / 65 R 15 88T M+S** as being printed on actual tyres as shown in Figure 1.

Participants were asked to interpret the meaning of the markings on the tyre. The result shows that out of the 1191 participants, only 20.9% explained **185** as the tyre sectional width which is the correct meaning, (27.7%) described **65** as aspect ratio or the sidewall height which is a perfect answer, only (16.8%) could correctly clarify "**R**" as radial ply construction with majority of participants (83.2%) describing **R** as rim which is not an appropriate interpretation. This implies that participants interchange **R** which is radial ply construction for rim.

In addition, majority of the participants (62.8%) correctly described **15** as rim size, (16.2%) defined **88** as load index, (4.2%) explained the **T** as speed rating and finally (8.4%) were able to explain **M+S** as mud and snow. It can be observed that most of the participants were only able to explain the rim size correctly. Furthermore, **T** which is the speed rating was the least identified among all the tyre marking characters. However, speed rating
